# Uploading new firmware

Upload of firmware through USB to IOMod device is done through CLI (Command Line Interface) on virtual COM port. Drivers needed for MS Windows to install VCOM will be provided. To open up CLI simply connect to specific VCOM port with terminal software (it is advised to use **PuTTY** terminal software. If other software is being used, user might need to send <return> symbol after each command). When connected user should immediately see main screen similar to one in Fig. 1.

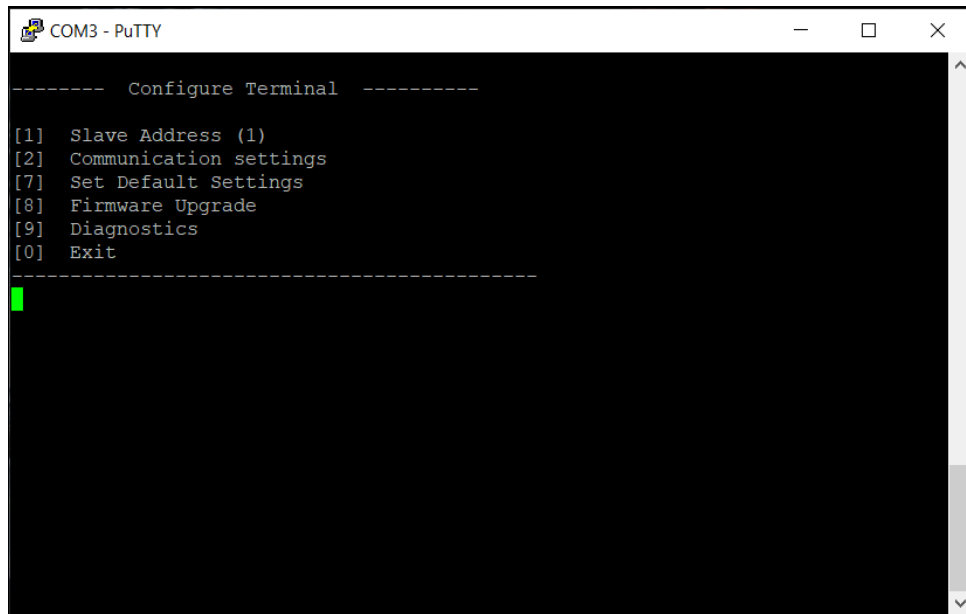
Fig. 1. PuTTY main screen.

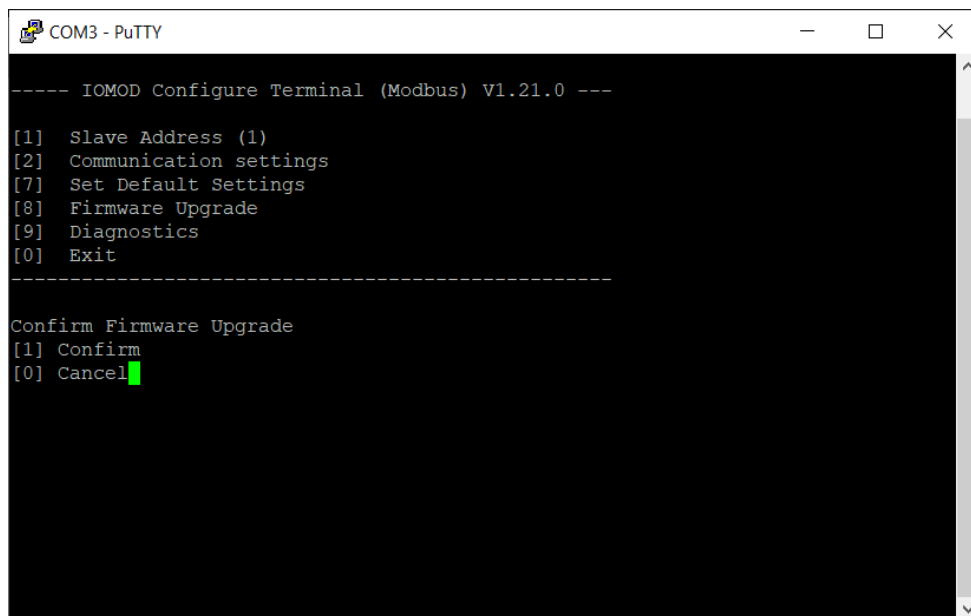
Fig. 2. Firmware upgrade confirmation screen.

Navigation is performed by pressing number connected to its function. User then should proceed by following further on-screen instructions. If terminal window is accidentally closed without exiting, user can connect to terminal again, and press any key on keyboard to show up main menu once again. For example, to upload new firmware to IOMod, in the main configuration menu press [8] to enter Firmware Upgrade screen and select confirm [1].

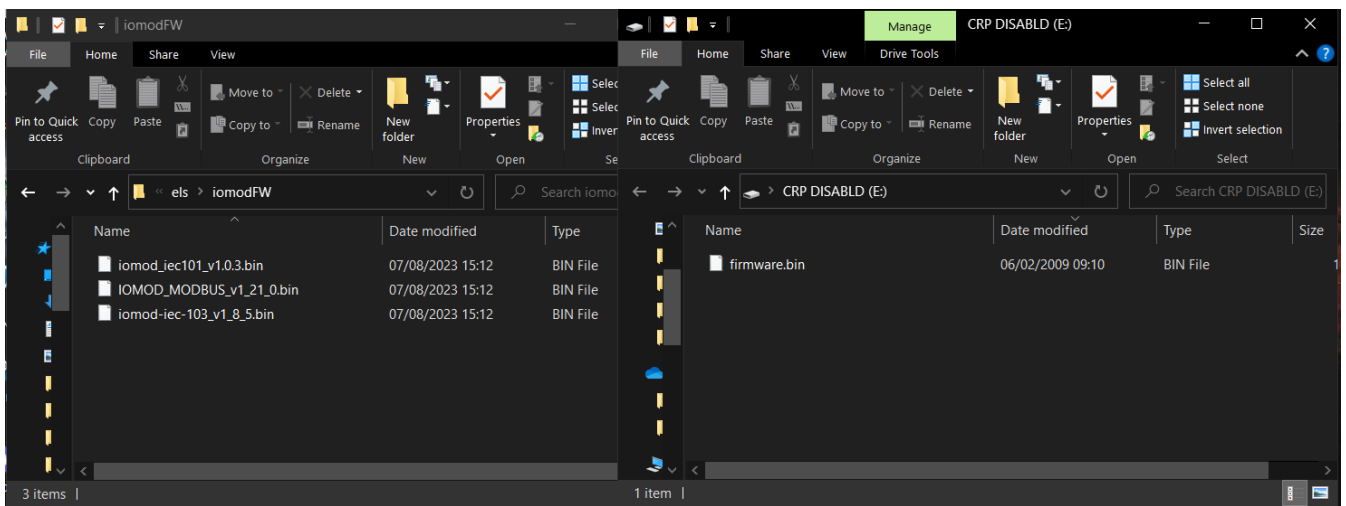
Fig. 3. Firmware "iomodFW" folder and the folder to delete "firmware.bin" and upload one of the new firmware.

User then must delete existing file "firmware.bin", and simply upload new firmware file by drag and drop (in this example after deleting "firmware.bin" user must drag and drop one the prepared firmware files on the left to the folder on the right).

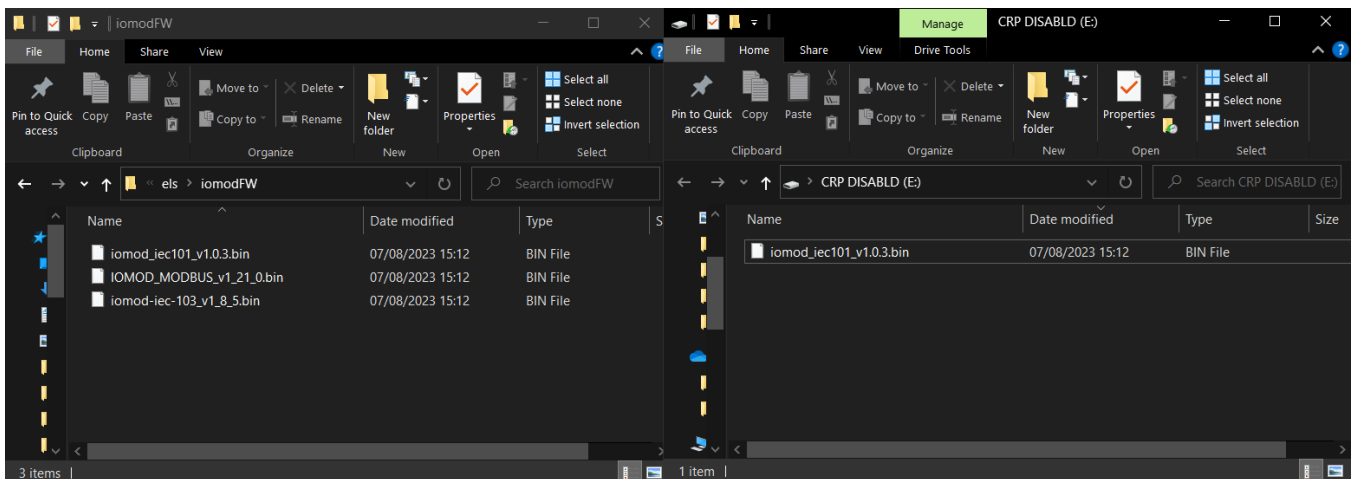
Fig. 4. Uploaded IEC-60870-5-101 firmware as an illustration.

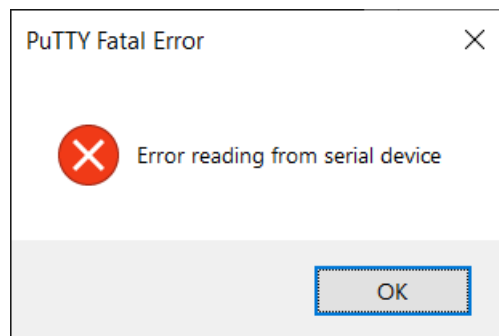
Fig. 5. Error caused by the upload.

After uploading the new firmware, user must exit the folder and dismiss the error caused by the firmware upgrade mode.

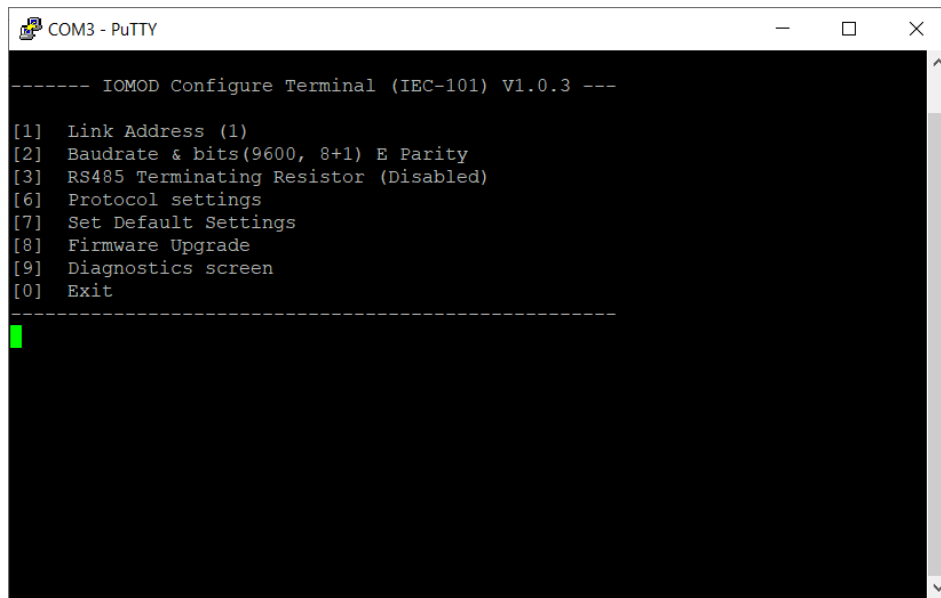
Fig. 6. Successful upload of new firmware.

🔔 Reconnect the device and check firmware version. It should now represent the one it was updated to.
